TECHNICAL REPORT HL-91-15

# HARRY S. TRUMAN DAM SPILLWAY AND POWERHOUSE, OSAGE RIVER, MISSOURI

## Hydraulic Model Investigation

### Volume I MAIN TEXT

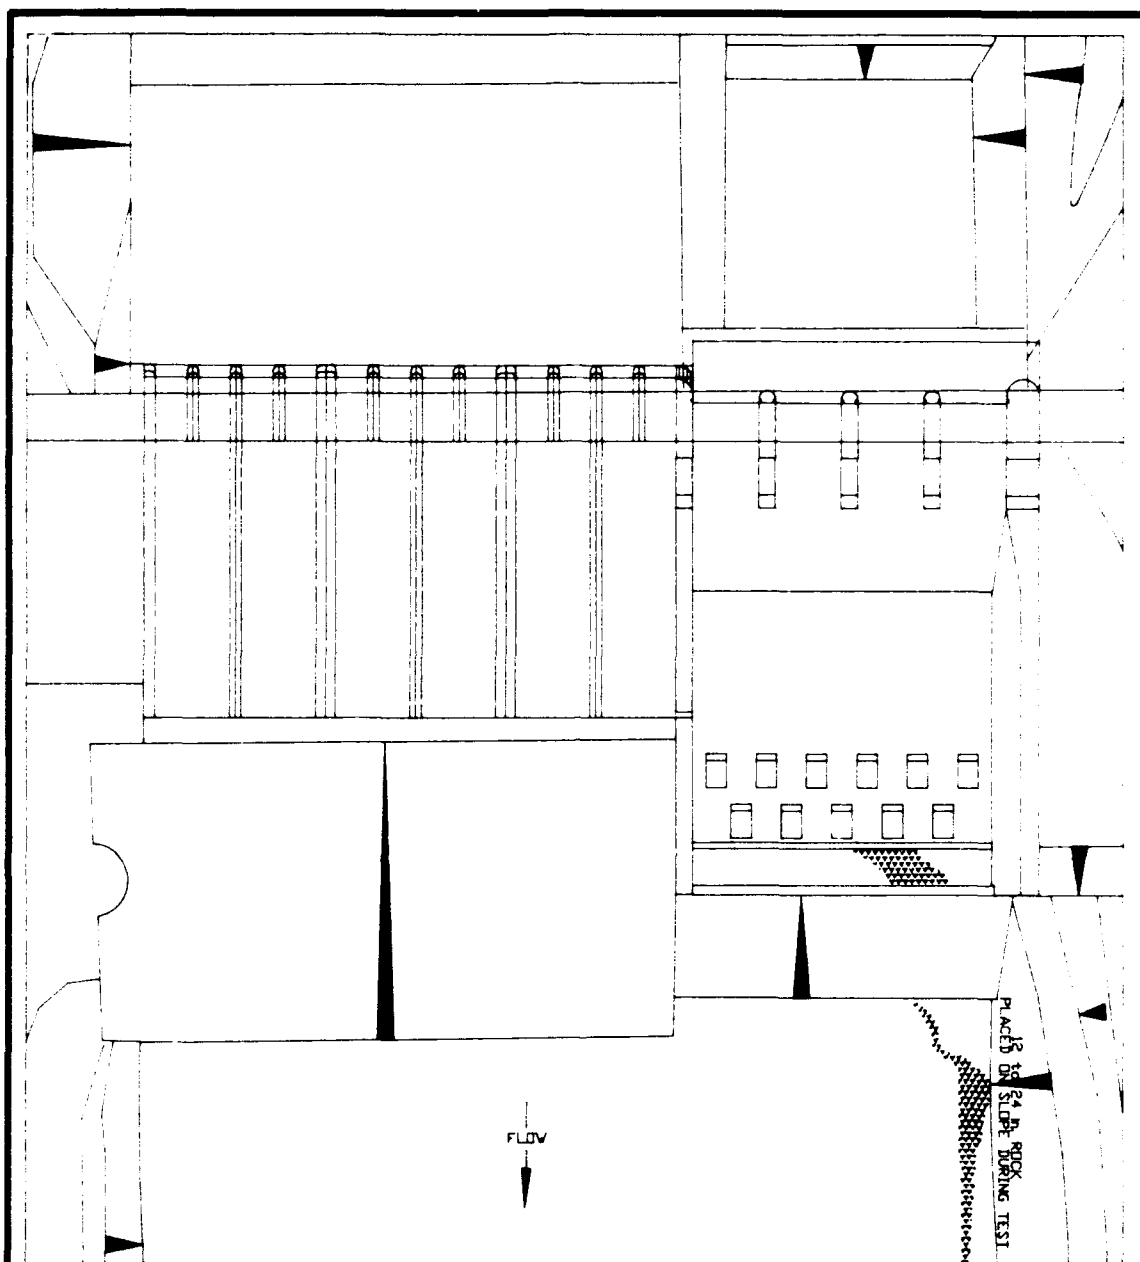
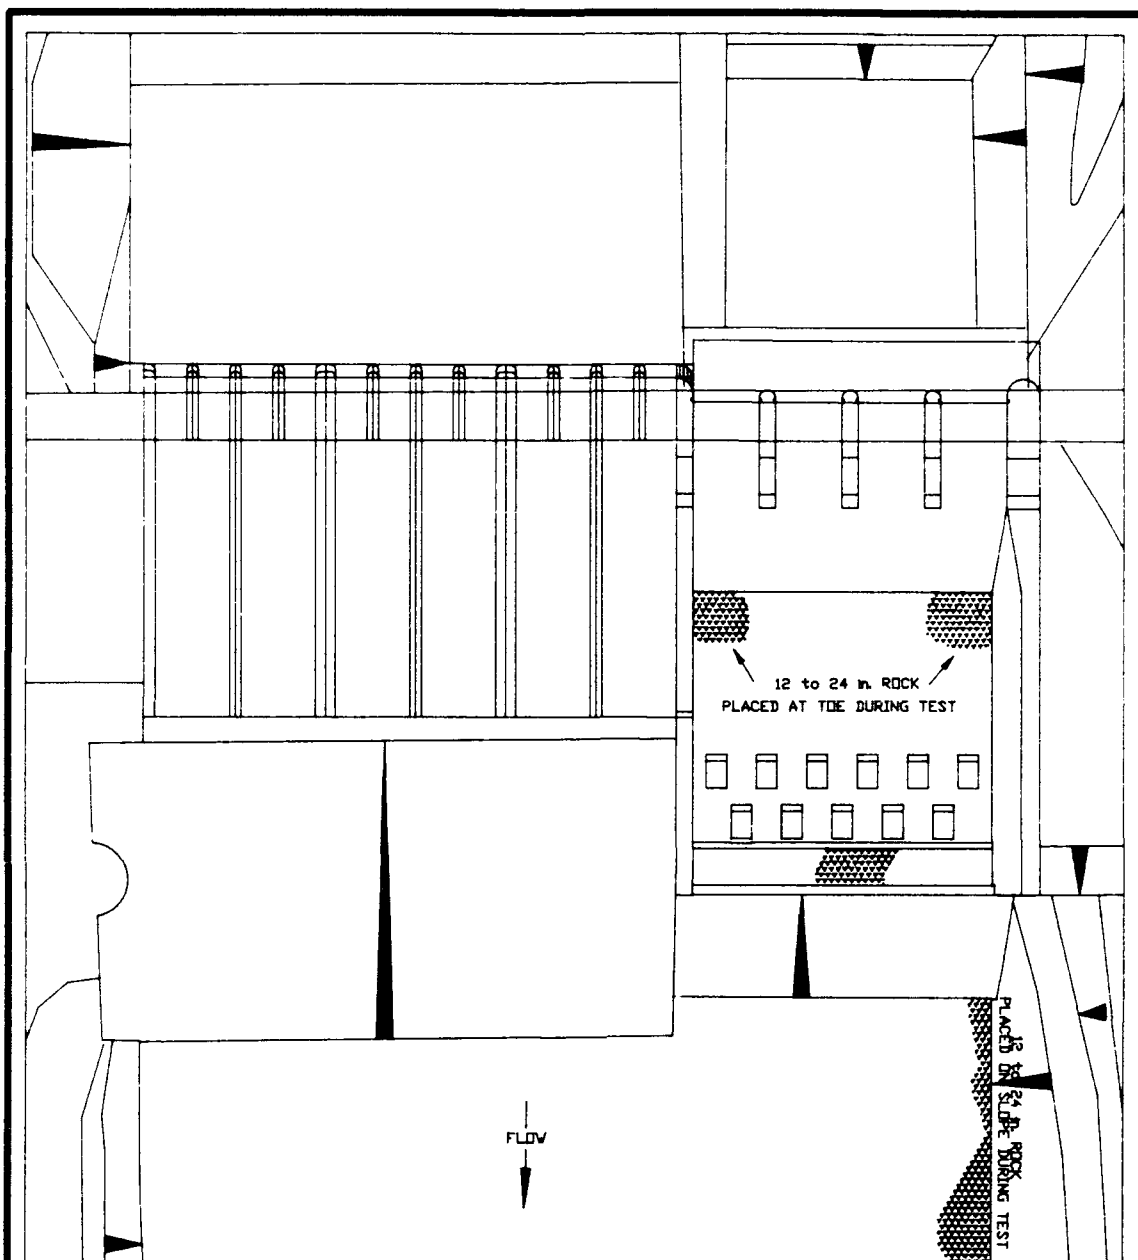
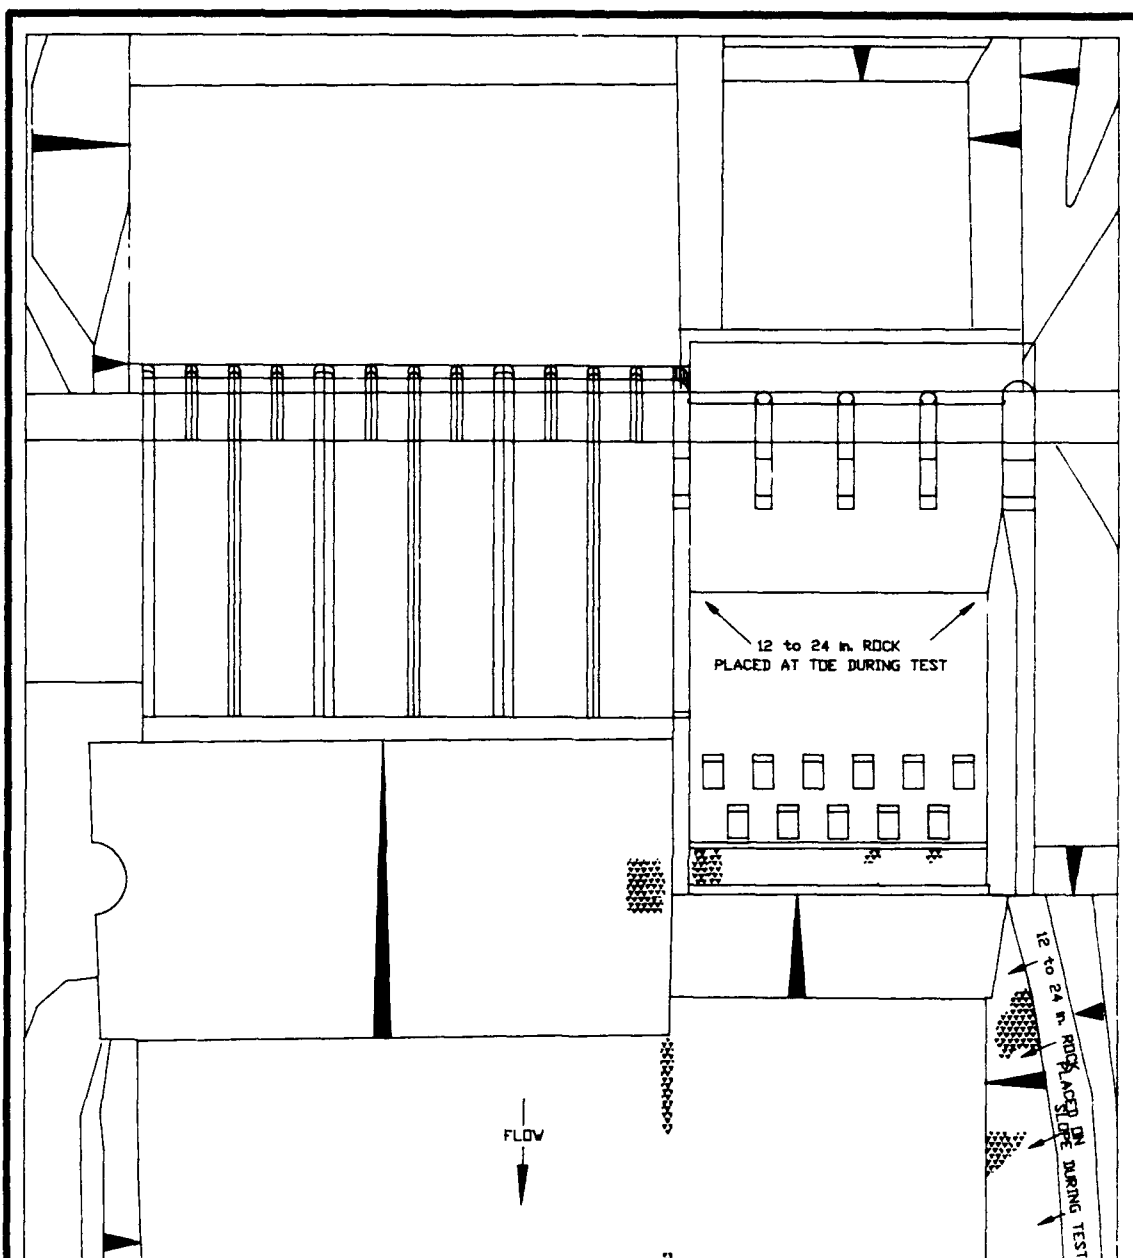
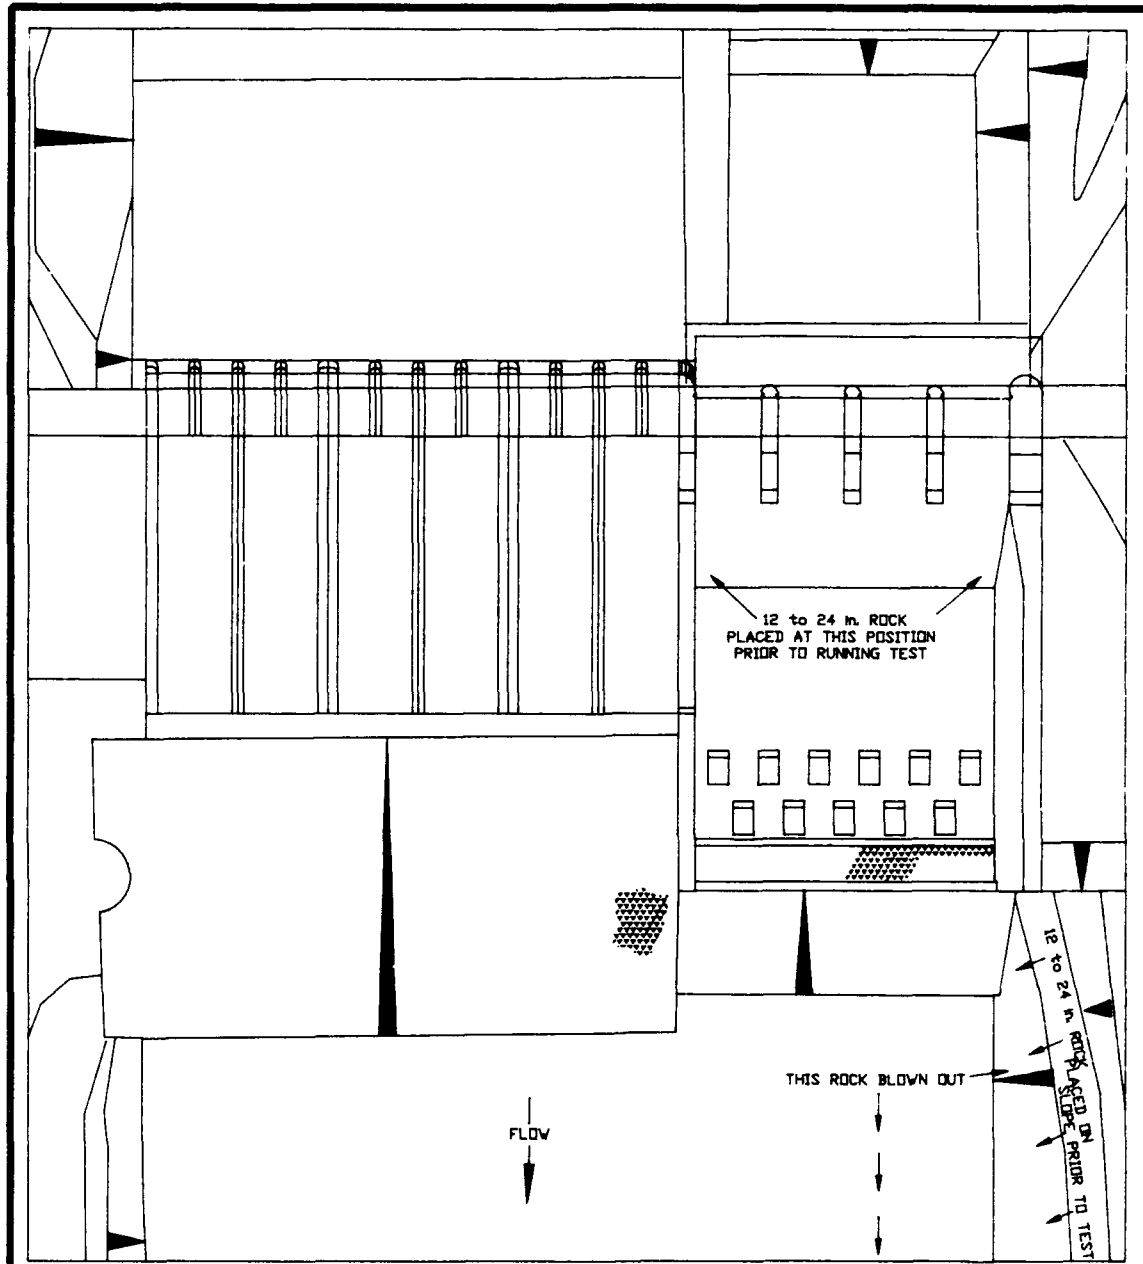
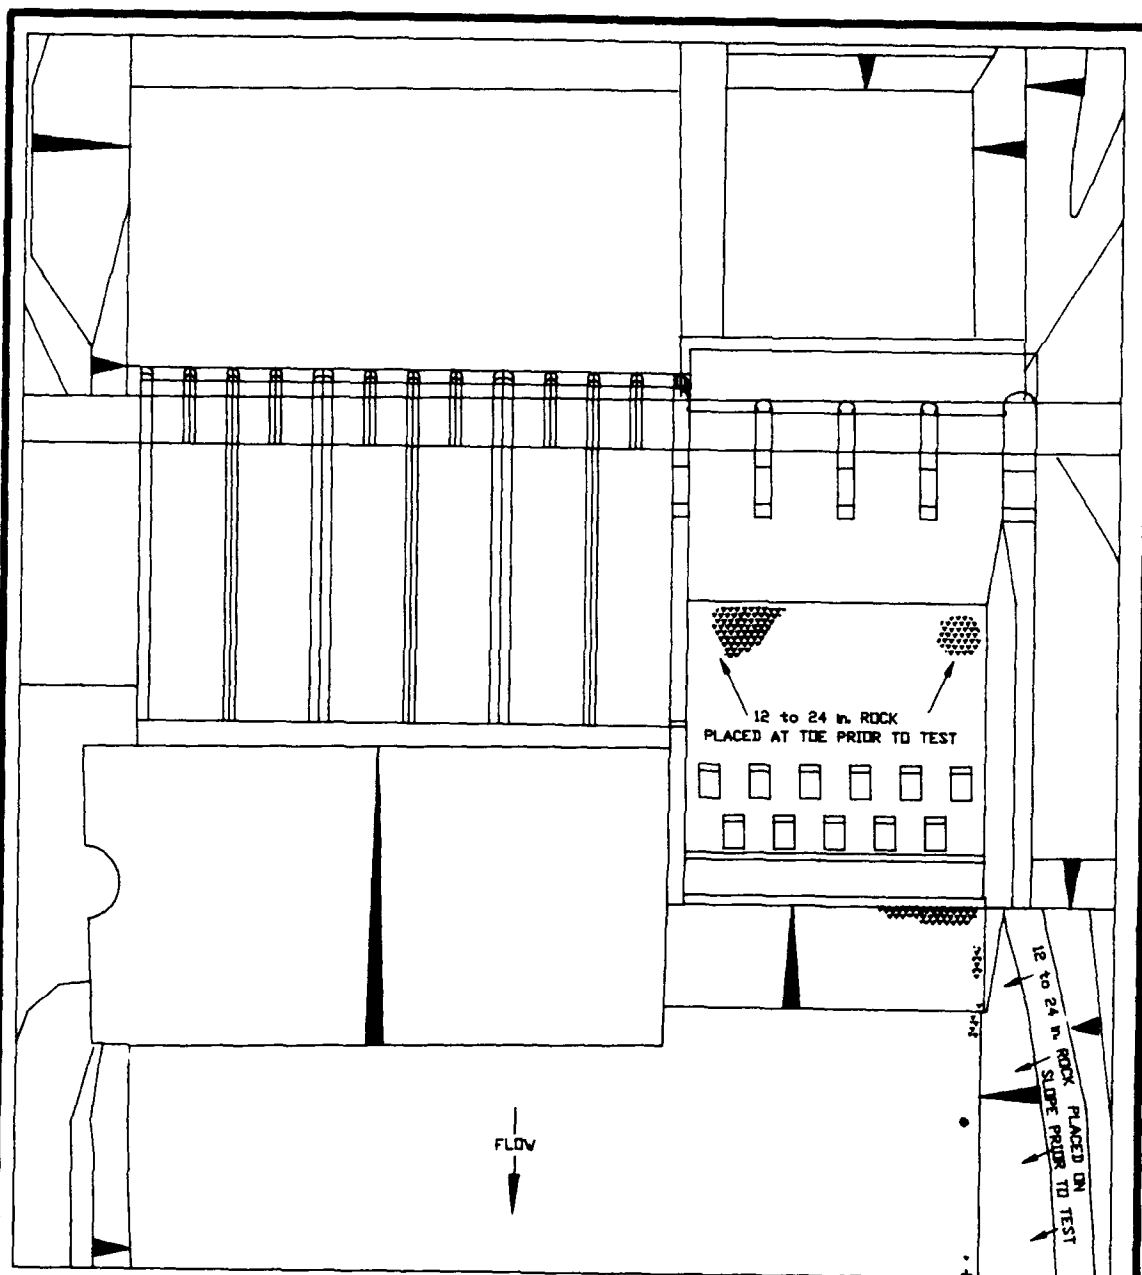
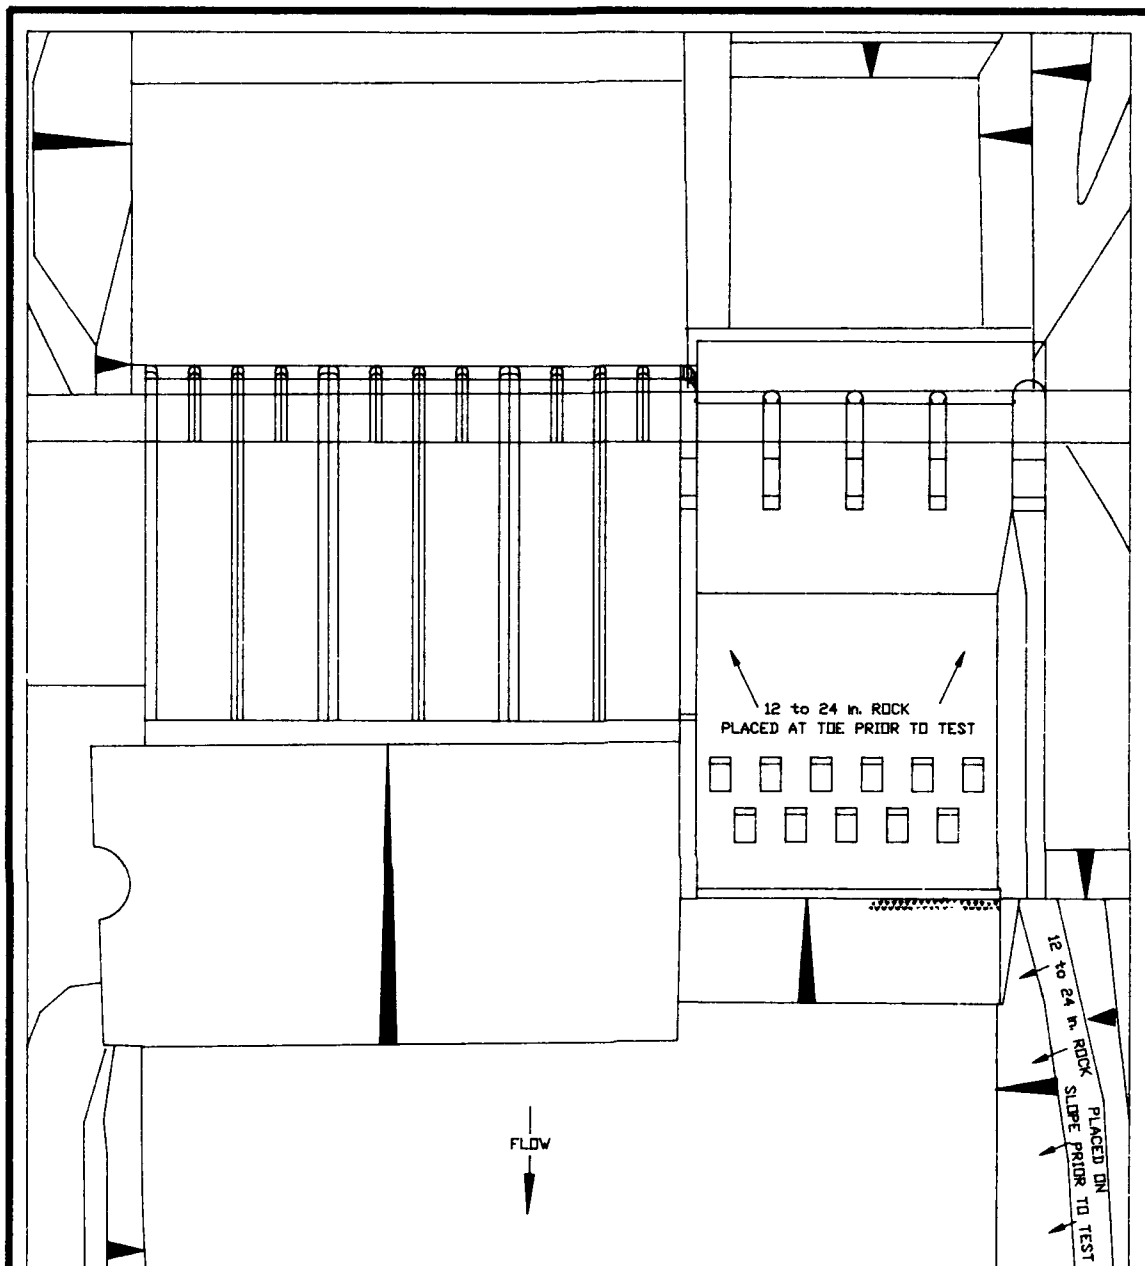
16. Plans to stop the rock from entering the basin consisted of building a rock trap (Plate 70). Plate 71 shows details of five types of traps tested. The type 1 rock trap successfully trapped the 12- to 24-in. rock when it was placed on the downstream side slope (Plate 72); however, during a test with rock already in the basin (Plate 73), the rock was not washed off. Rock already in the basin was deposited in the same location of the damage in the prototype. With a 200,000-cfs spillway discharge, the type 1 rock trap

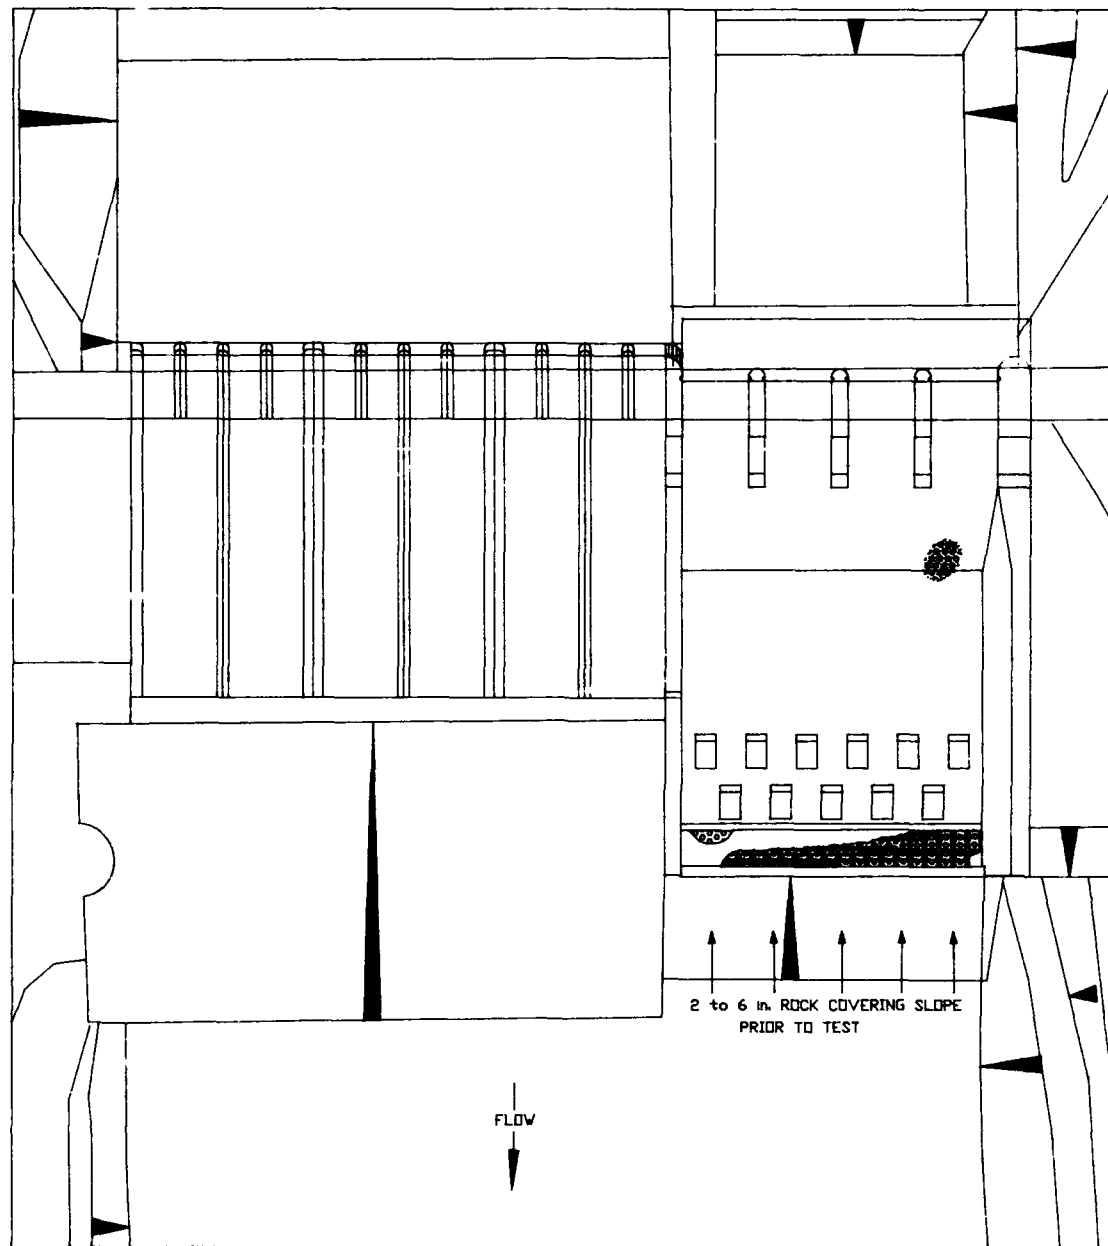
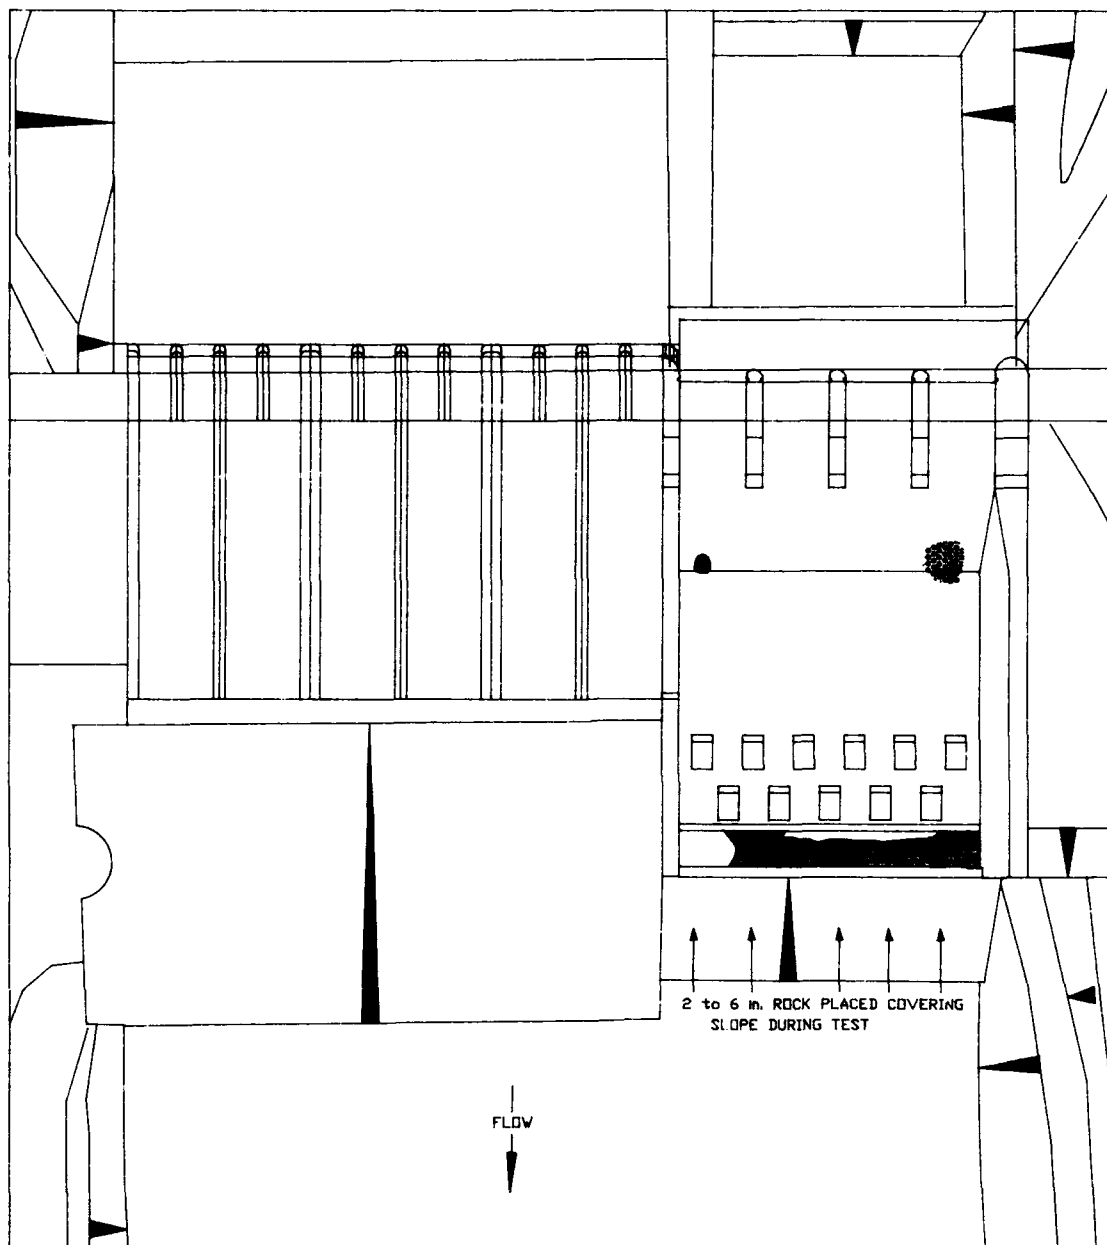
19. The types 1-5 rock traps (Plate 71) were tested and failed to trap the smaller material. Plates 82 and 83 present the results of displacement tests using the 2- to 6-in. stone size for the type 5 rock trap. The type 5 rock trap failed to trap all of the material. Plates 84 and 85 show the results of tests with the type 5 rock trap and a 12- to 24-in. stone size. Since the type 5 trap used a 16-ft-high wall, questions arose about whether a wall of this height could be feasibly anchored in the wet. Also, the type 5 rock trap adversely influenced the stilling basin performance for the 200,000-cfs spillway discharge.

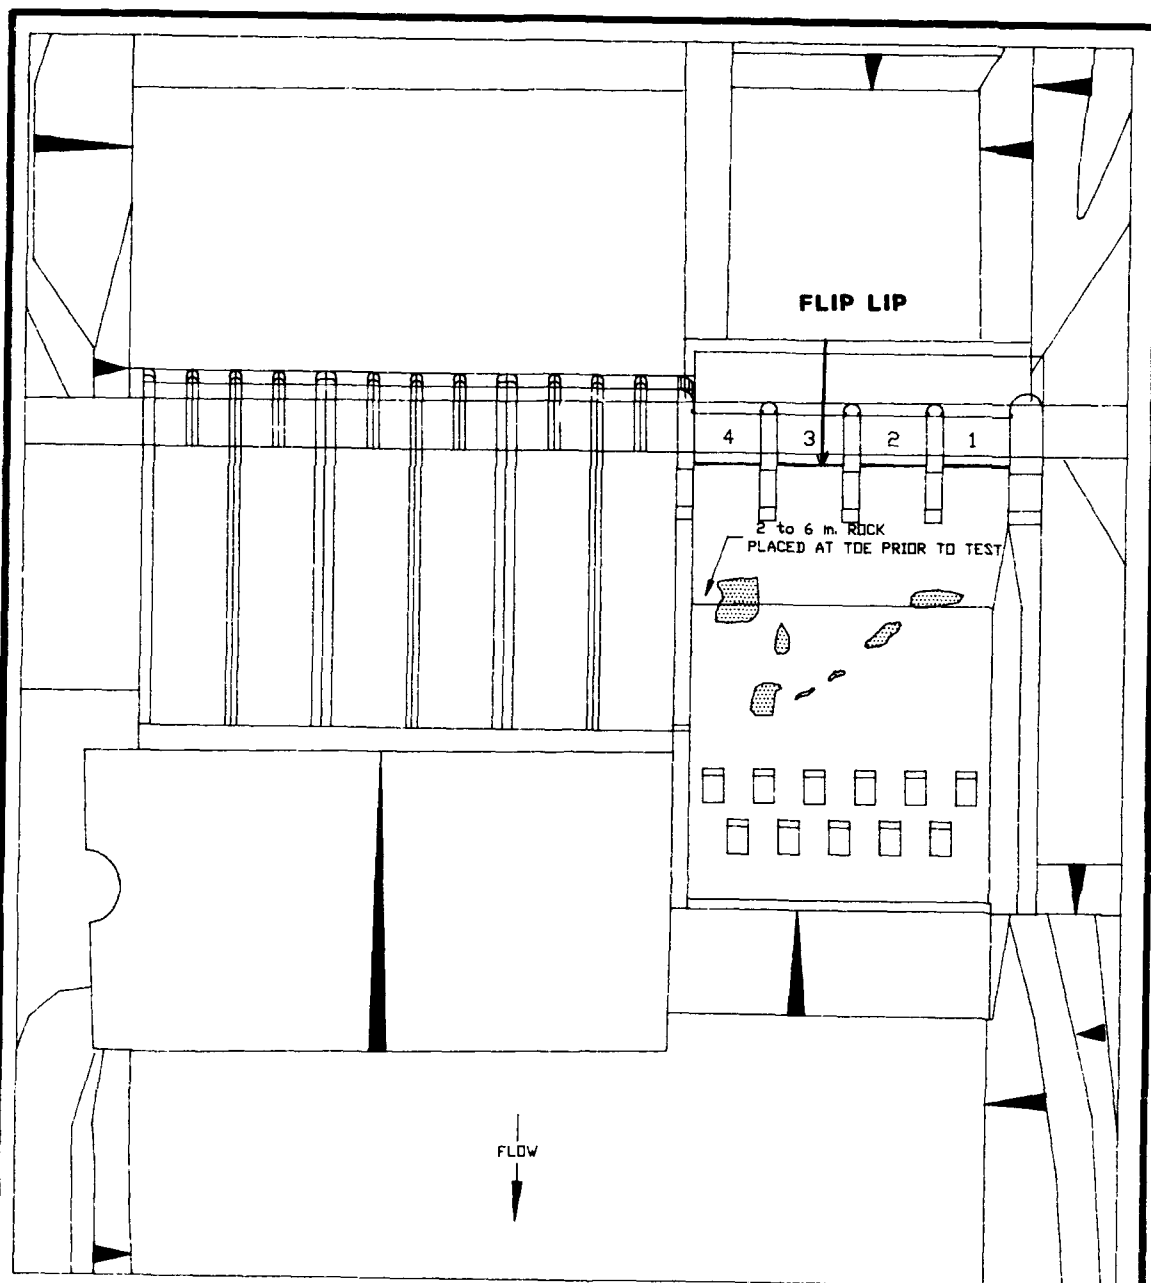
**STONE DISPLACEMENT TEST NO. 23**  
 TAINTER GATE NO. 4 OPEN 1 FT  
 POWERHOUSE GATES CLOSED  
 POOL EL 730.0, TAILWATER EL 662.0

22. Stone displacement tests with the as-built stilling basin were conducted for several combinations of operating conditions, as documented in Plates 96-100. Test 23 (Plate 96) consisted of placing 2- to 6-in. rock at the toe of the spillway trajectory prior to operation. Tests were then run with tainter gate 4 open 1 ft at pool el 730.0 and tailwater el 662.0 and the powerhouse closed. As shown in Plate 96, the small rock stayed within the basin. Test 24 (Plate 97) had 65,000-cfs powerhouse flow, all powerhouse gates open, all four tainter gates fully closed, with pool el 706.0 and tailwater el 662.0. None of the 2- to 6-in. rock placed at the toe of the spillway moved.

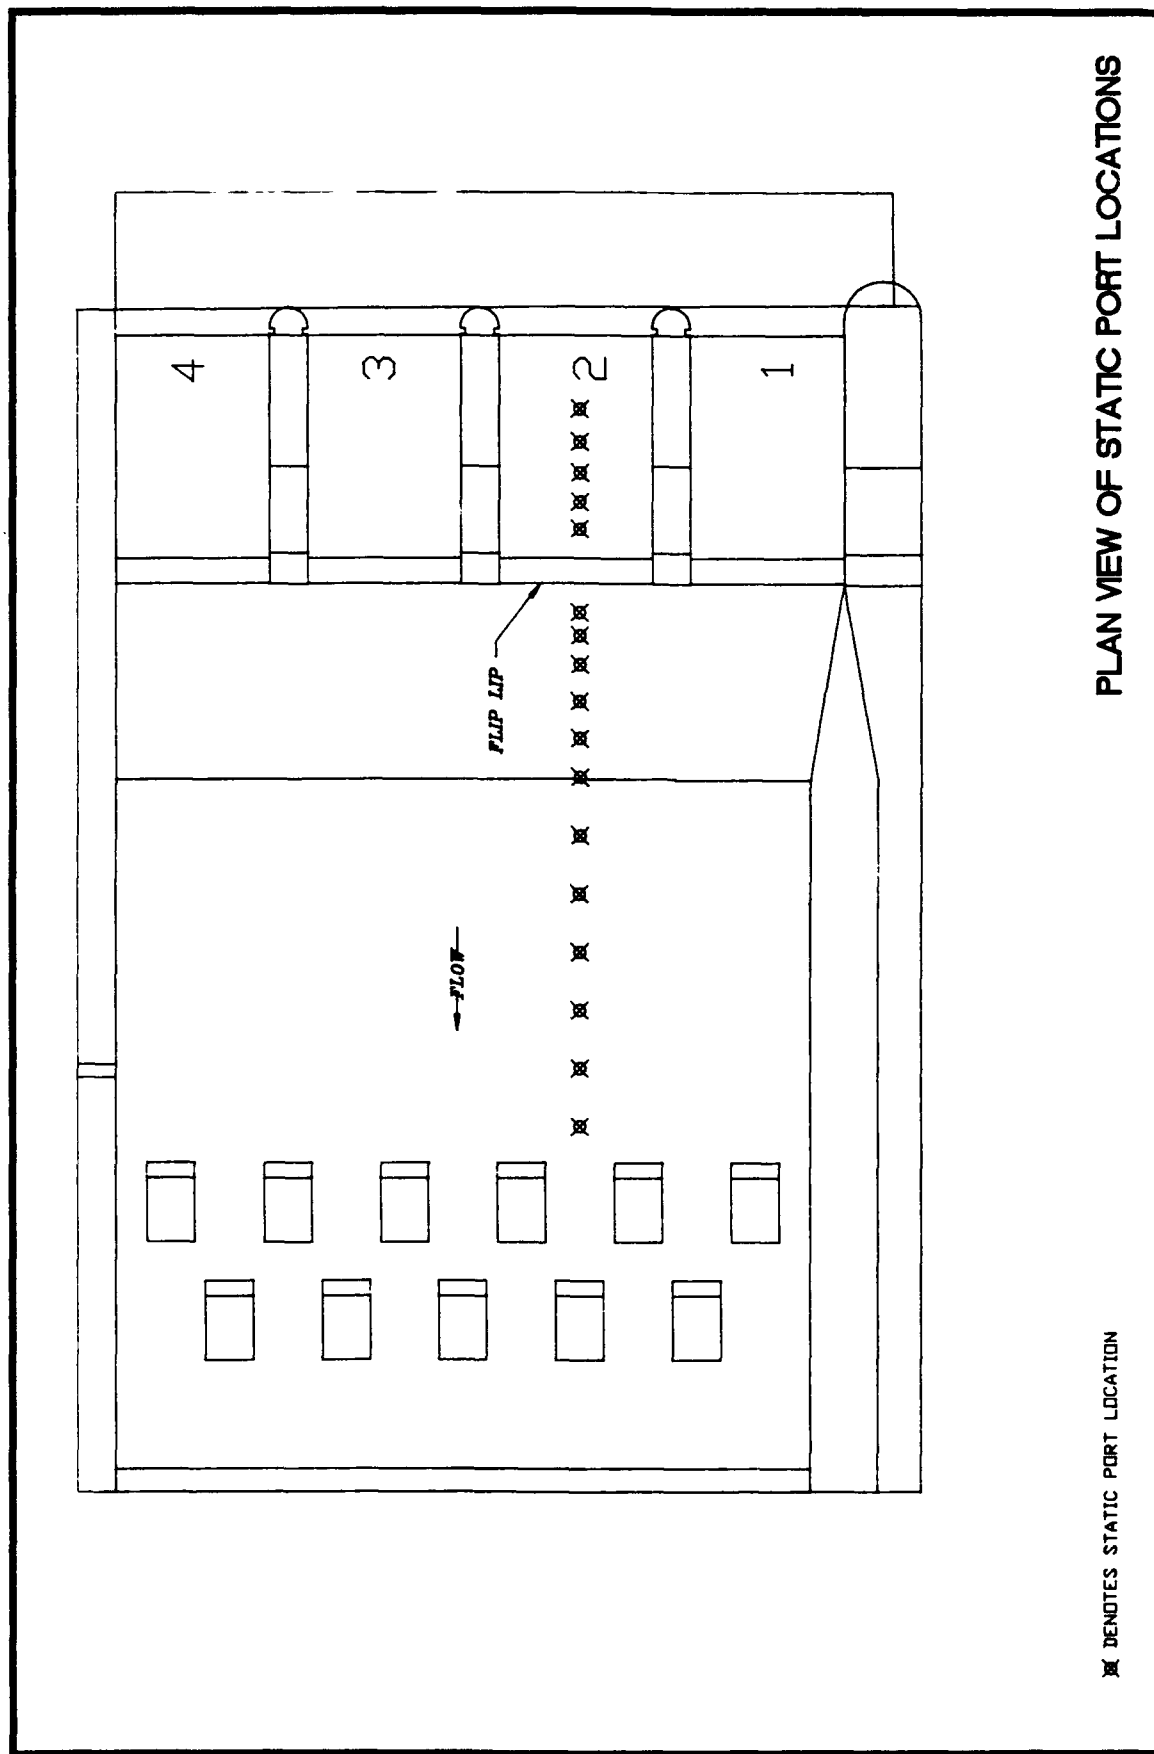
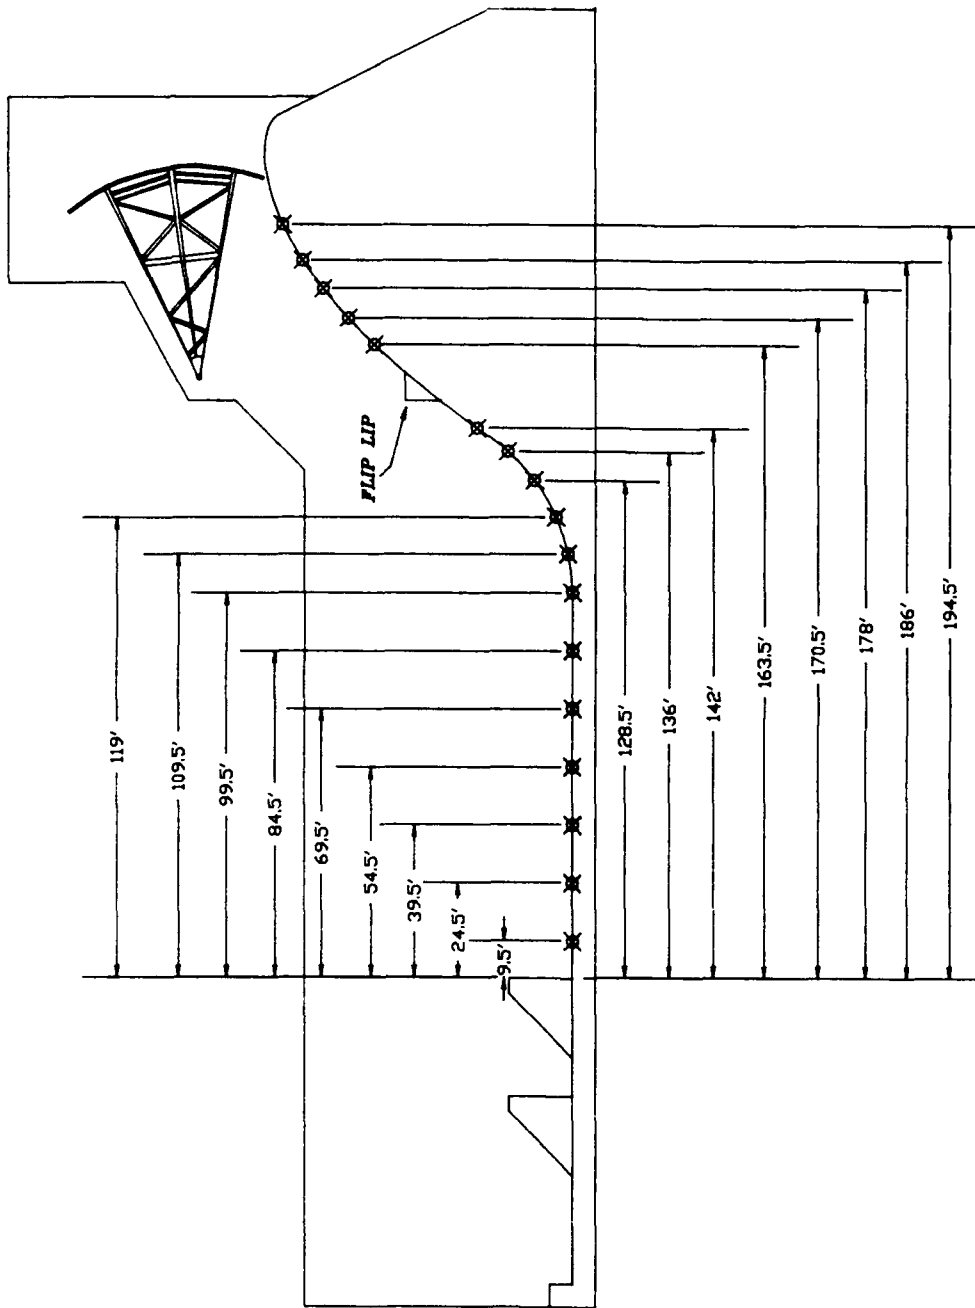
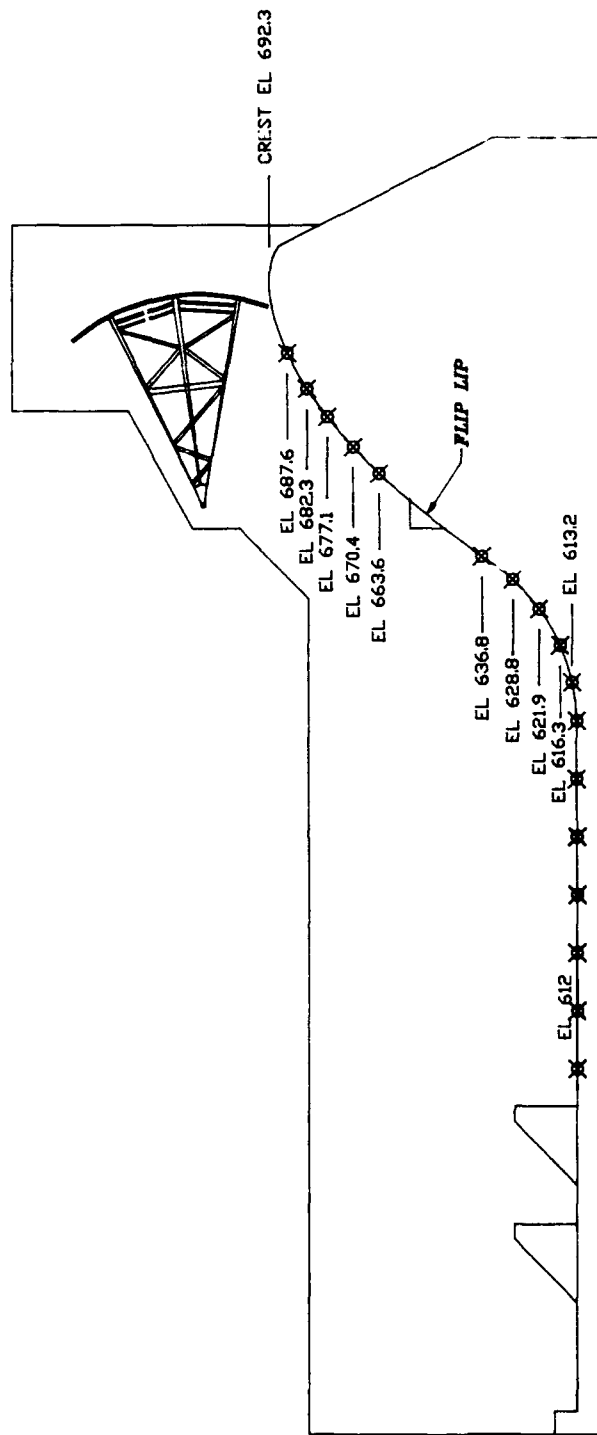
PLAN VIEW OF STATIC PORT LOCATIONS

29. Hydrostatic pressure profiles were obtained with the as-built design for a range of discharges. The location of the static ports (piezometers) is provided in Plates 108-110, and data plots are shown in Plates 111-115. No tendency for cavitation was indicated by the plots.

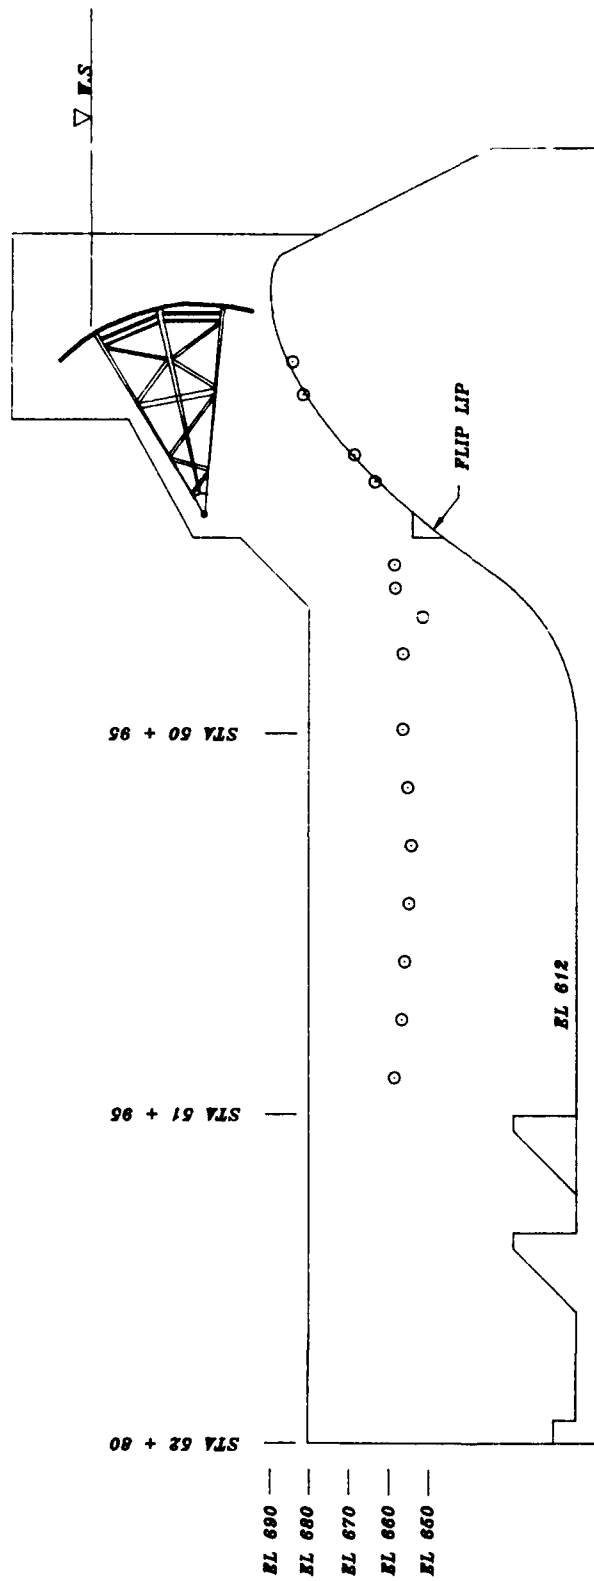
# **HYDROSTATIC PRESSURE PROFILE**

- SPILLWAY 49,000 CFS
- POWERHOUSE 29,000 CFS
- SPILLWAY GATES 1, 2 OPEN 4.7 FT.
- SPILLWAY GATE 3 OPEN 8.7 FT.
- SPILLWAY GATE 4 OPEN 12.7 FT.
- POOL EL 738.7, TAILWATER EL 665.3

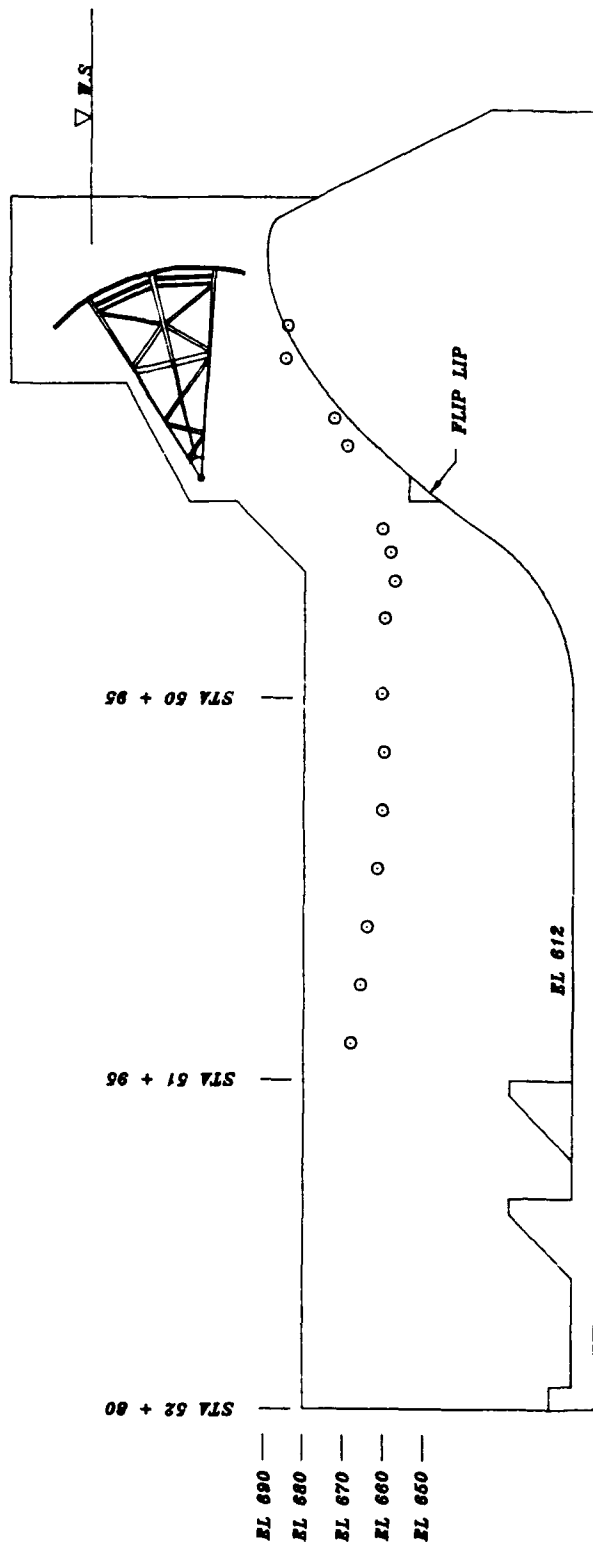
# **HYDROSTATIC PRESSURE PROFILE**

SPILLWAY GATES 1-4 OPEN 7.7 FT

POOL EL 736.7, TAILWATER EL 665.4

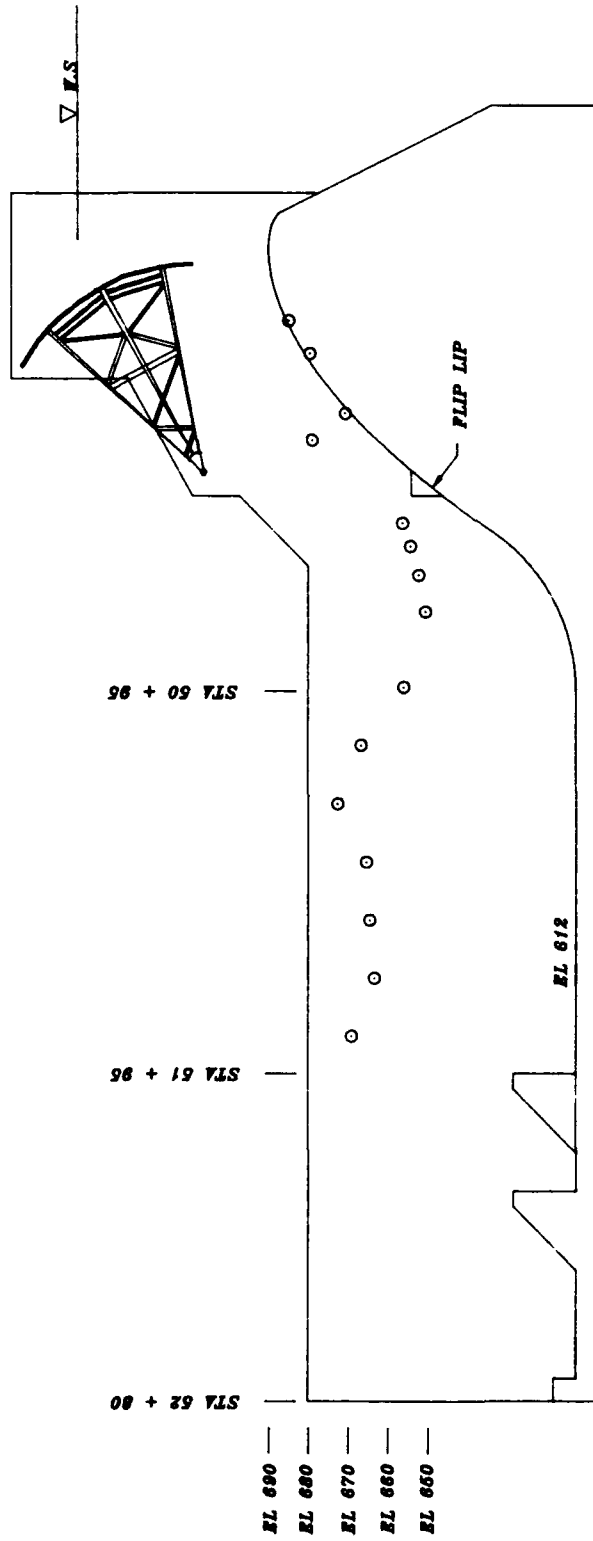
# **HYDROSTATIC PRESSURE PROFILE**

DISCHARGE 1  
 SPILLWAY 100,000 CFS  
 POWERHOUSE 32,500 CFS  
 SPILLWAY GATES 1-4 OPEN 19 FT  
 POOL EL 742, TAILWATER EL 668.3

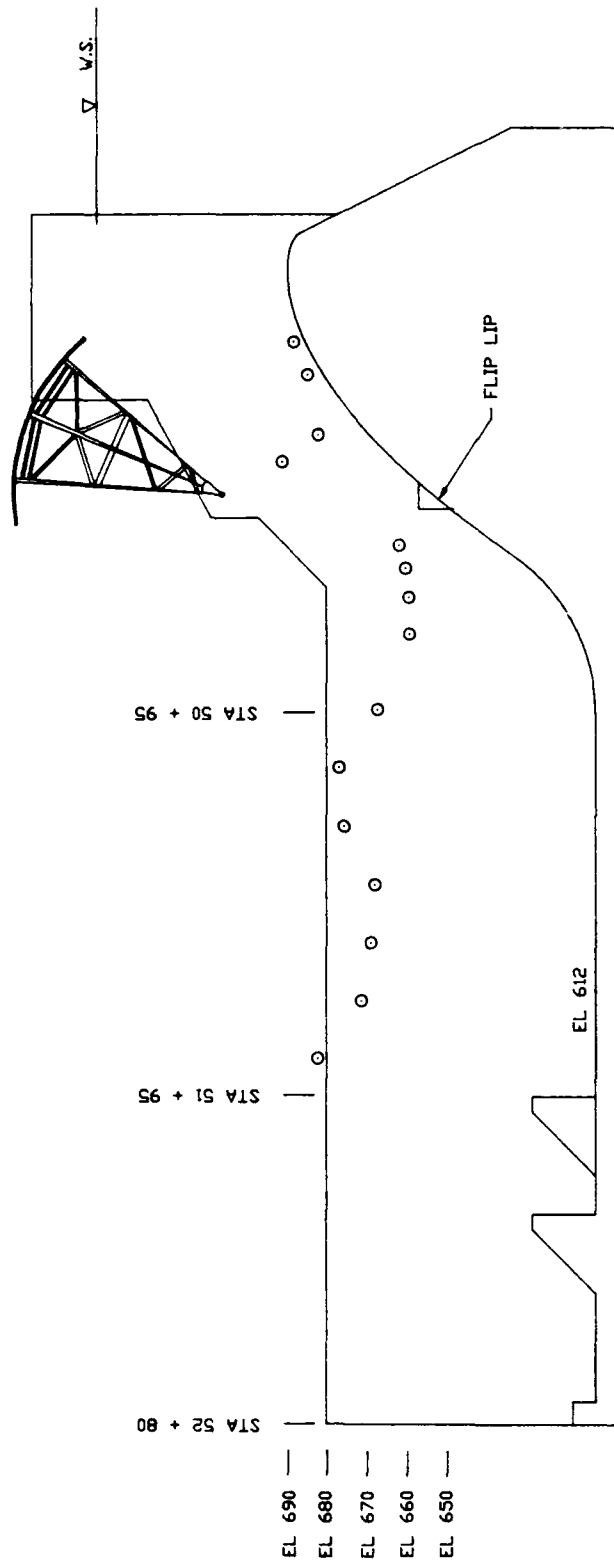
# **HYDROSTATIC PRESSURE PROFILE**

DISCHARGE 1  
 SPILLWAY 229,000 CFS  
 ALL POWERHOUSE GATES CLOSED  
 ALL SPILLWAY GATES FULL OPEN  
 POOL EL 742.0, TAILWATER EL 675.0
